Defected Composite Laminates Assessment Using C-Scan Technique

Rashed A. Abdulsalam¹

Abstract:

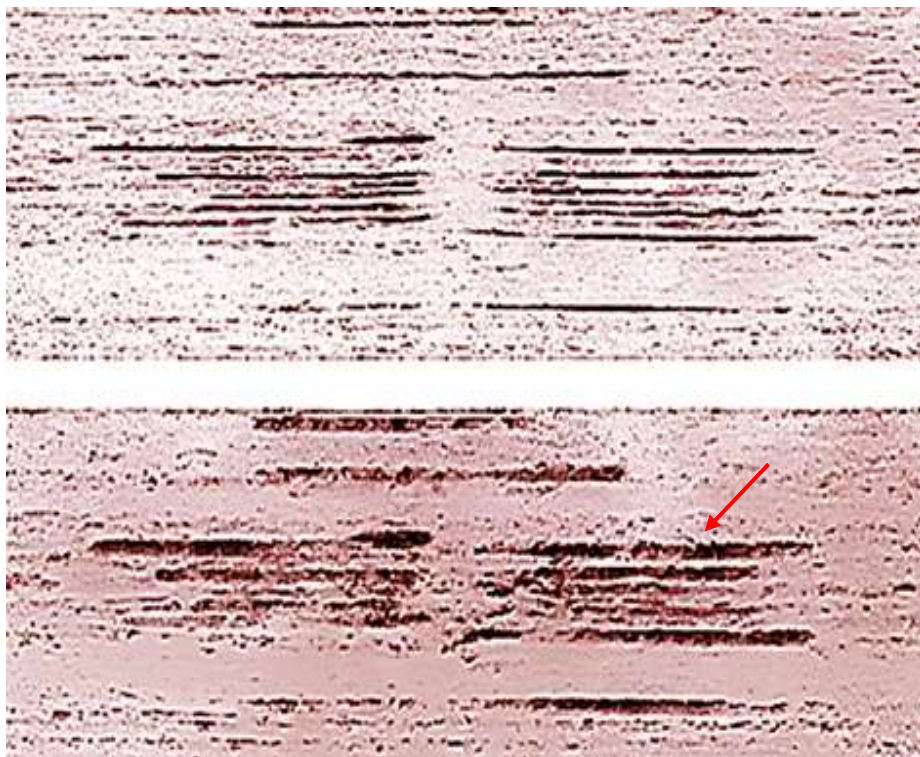
Fig.(3). Gate width's effect on the accuracy of backscattered echoes' crack imaging. Gate widths are as follows

(upper: 55 ns; lower: 350 ns) C-scan.

Gate domain effect on effectiveness of back spreading scanning for matrix fracture is highlighted in the analysis shown in Figur (3). which clarifies the impact of the gate domain on the aforementioned photography technique. The reconstructions were obtained using gates with durations of 55 ns and 350 ns, respectively.
